A. M. J. de Kraker

This discussion paper is/has been under review for the journal Hydrology and Earth System Sciences (HESS). Please refer to the corresponding final paper in HESS if available.

Flooding in river mouths: human caused or natural events? Five centuries of flooding events in the SW Netherlands, 1500–2000

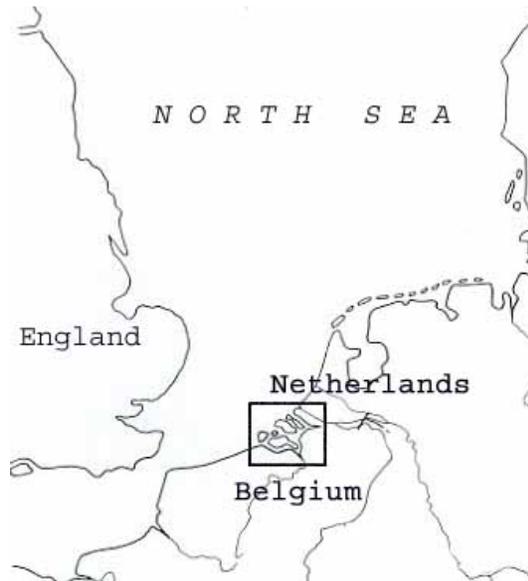
Figure 1. The former archipelago of the mouths of River Western Scheldt, Eastern Scheldt and River Meuse. The study area in the box consists of the Dutch provinces of Zeeland, the western part of North Brabant and the area south of Rotterdam.

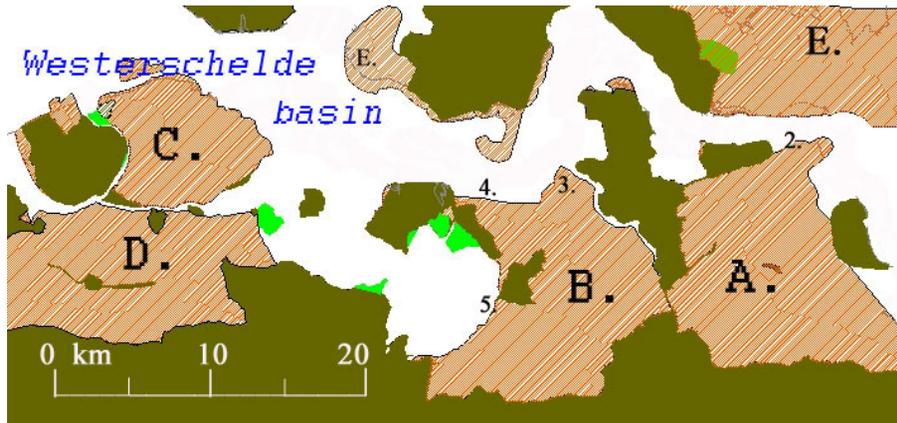
Figure 2. Strategic flooding during the Eighty Year's War (1568–1648) in Zeeuws-Vlaanderen. (A.) Flooded in February 1584 at no 2., (B.) area flooded in July 1584 and the southern area flooded in July 1586 at no 5. (C.) Area flooded in 1584. (D.) Area flooded in 1584, then reclaimed again and flooded again in 1621–1622. (E.) Areas flooded during storm surges, 1530, 1532 and 1570.

Areas in the province of Zeeland, north of the Westernscheldt basin were very badly hit during storm surges of the 16th century of which vast areas remained under water for a very long time (Fig. 2 areas E).

1584. In July 1586 another inundation was caused near Axel (Fig. 2 no 5 area B), but this did not serve to relieve Ghent anymore which was already dominated by the Spanish (de Kraker, 1997, 335–337). The carefully chosen places to make breaches in the seawall or to simply take out a wooden sluice had a devastating impact on the landscape, but this strategy completely missed its directly anticipated goals. Bruges, Ghent and Antwerp were subdued by the Spanish in the course of 1584 and 1585, leaving the rebel side empty handed. The impact of these flooding events on the landscape were without precedent, because even secondary dikes (dikes in second line) were also affected, finally flooding about 2/3 of the late medieval landscape. The flooded zone also isolated the area from its historical hinterland, from which money usually came and decisions were made for repairs. From the rebel side all possible money for repairs went to the military and was not spent on newly conquered areas of which control remained uncertain. As the area became a frontier between the two warring parties, there was no rush to carry out fast repairs. Besides, nobody could survive in the flooded area. In fact the vast flooded land, which separated the warring parties, was gradually considered to be a rather practical solution to avoid any kind of hostile engagement in the field.

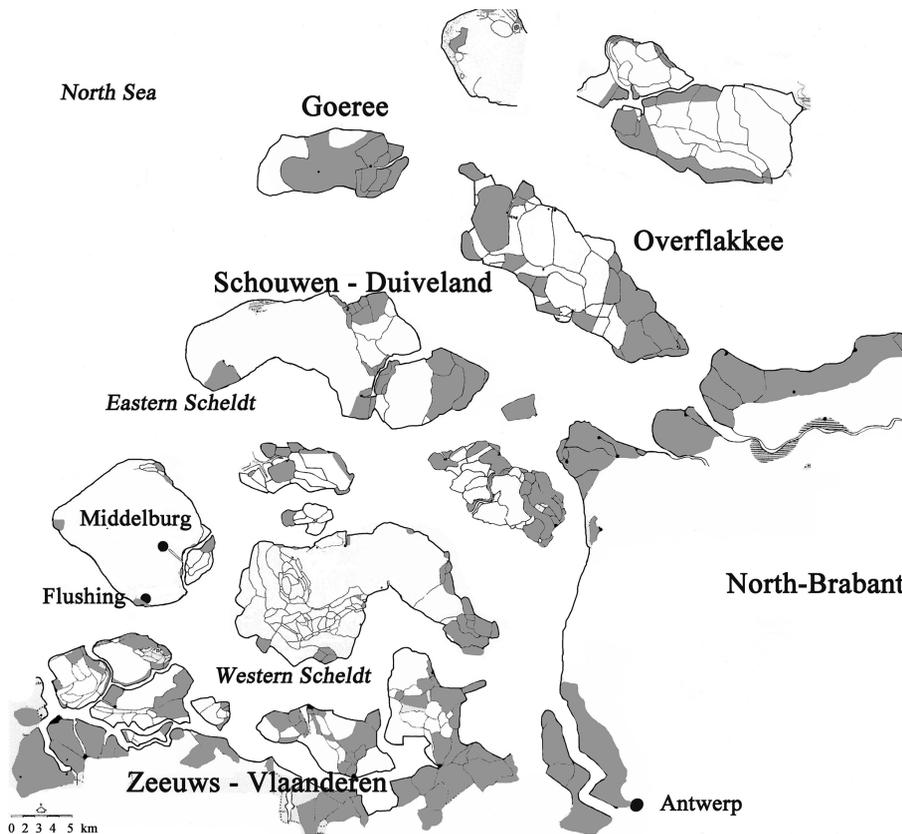
Figure 3. Reconstruction of the flooded areas (shaded) on the main islands and in the western part of North-Brabant during the storm surge of 26 January 1682 (Gottschalk, 1977).

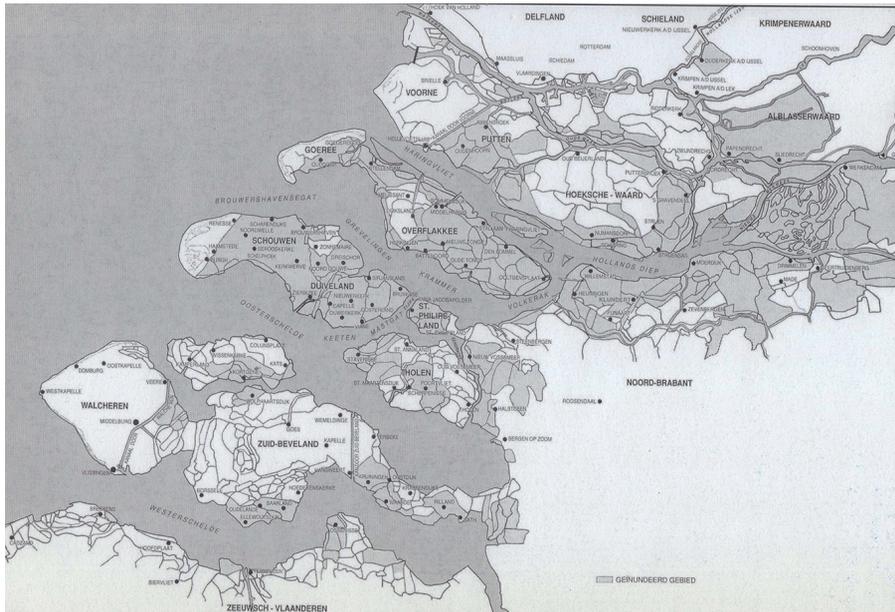
Figure 4. Reconstruction of the flooded areas (shaded) in Zeeland, parts of the provinces of South Holland and North Brabant during the storm surge of 1 February 1953.

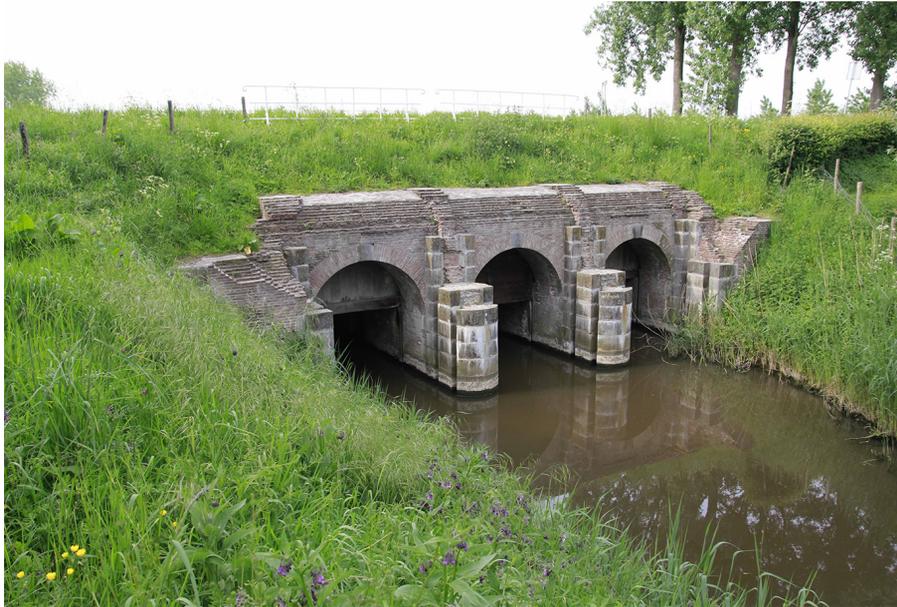
Figure 5. Land side of an inundation sluice, built in 1789 by the Estates General of the Dutch Republic at Zwartenhoek (51°15' N and 3°51' E). Notice the double groove in the protruding parts in which beams could be installed. As the space in between the beams could be filled with earth, this construction was strong enough to prevent the fresh water from flowing seaward. After some weeks water in polders could reach a level of some decimeters. As soon as the threat of war disappeared, beams and earth were removed again (photo, Nellie de Kraker).

At the start, strategic flooding events mainly used sea water, but by the end of the 18th century fresh water could also be used, by simply leaving sluices closed. This last

case required the building of special parts in the big sluices that were built of stone and brick.
